Plum Run Restoration of the Culvert in the Gordon Natural Area

by Israel Berrios, Katie Walston and Kristen Koller

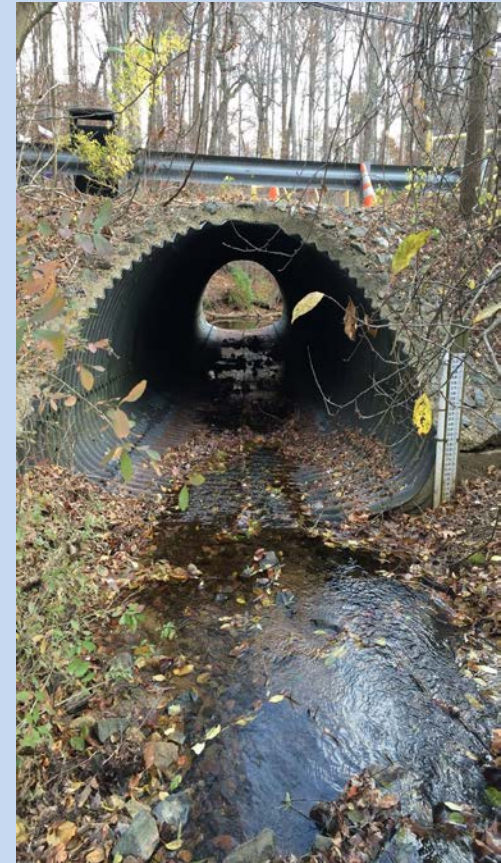
- Plum Run is separated into two main branches: The West Branch and the East Branch
- Our site of concern is located within the East Branch adjacent to the Gordon Natural Area entrance and athletic fields on south campus
- Site picked due to rapidly increasing impairment

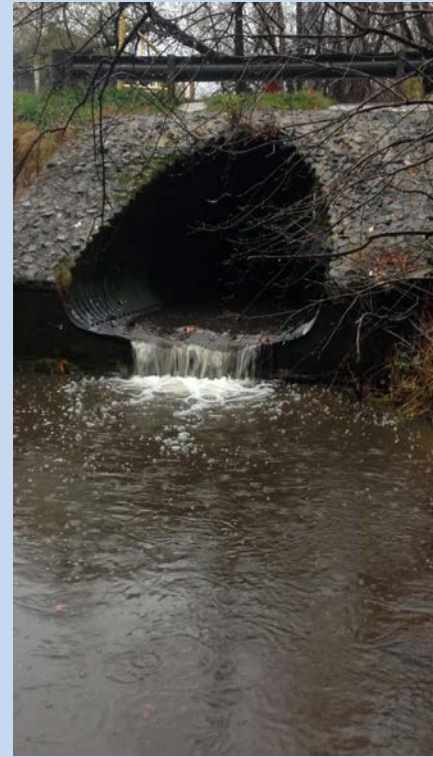
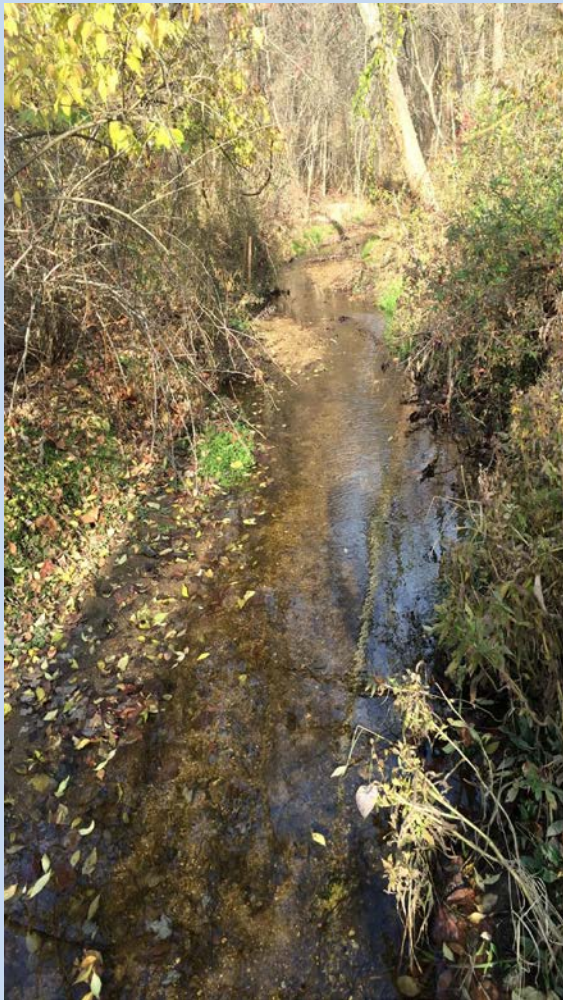
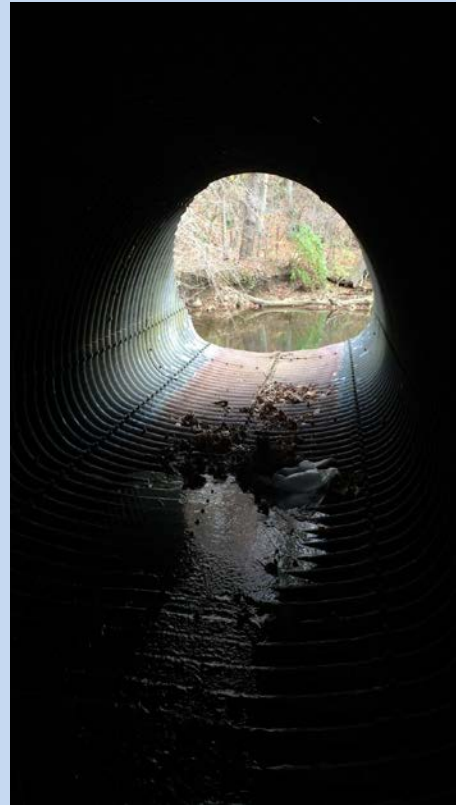
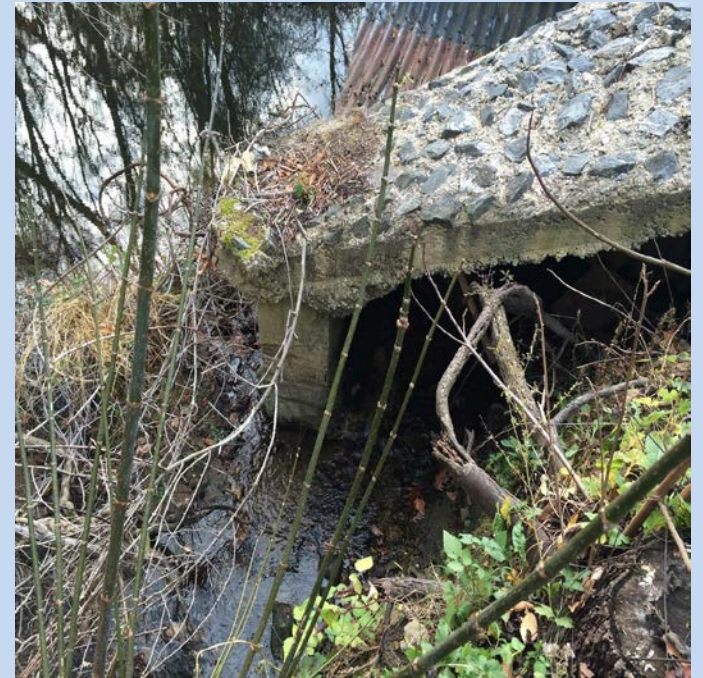
Problem: Culvert

- The water flows around and under the culvert rather than through it
- Connectivity is greatly reduced
- Discharge has decreased (the culvert acts as a dam, which is not the original purpose)
- Only during heavy rain events is water level high enough to flow through

Taking out the corrugated round culvert (A) and replacing it with a structural plate-arch (C).

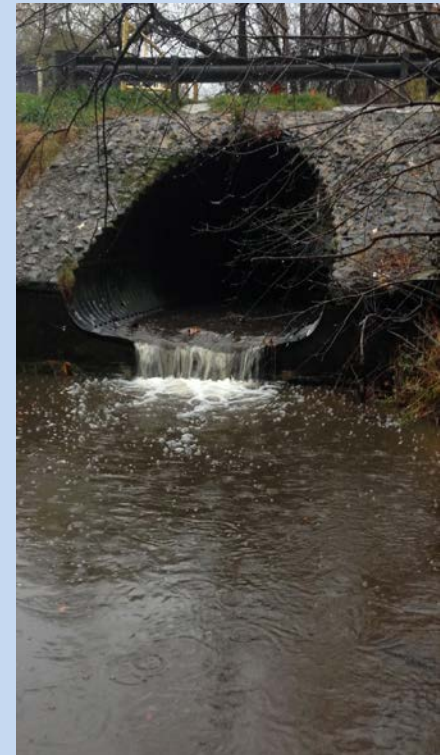
Round Culvert Issues for Fish

- Width constriction (Not so much in this case)
- Most culverts are elevated at the outlet end which creates an outfall barrier for the fish

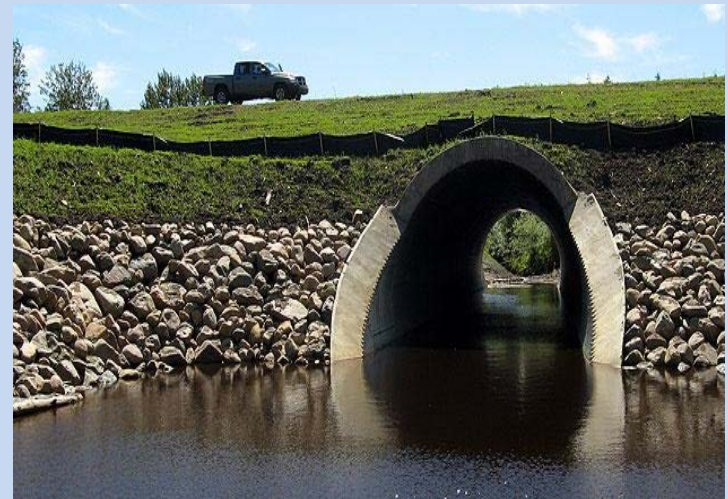
Benefits to Using a Structural Plate Arch

- Natural streambed is left mostly unchanged so there are no issues with water flowing under or around the culvert
- Little to no significant change to water velocity so sediment deposition won't be that big of an issue on the inlet end of the culvert

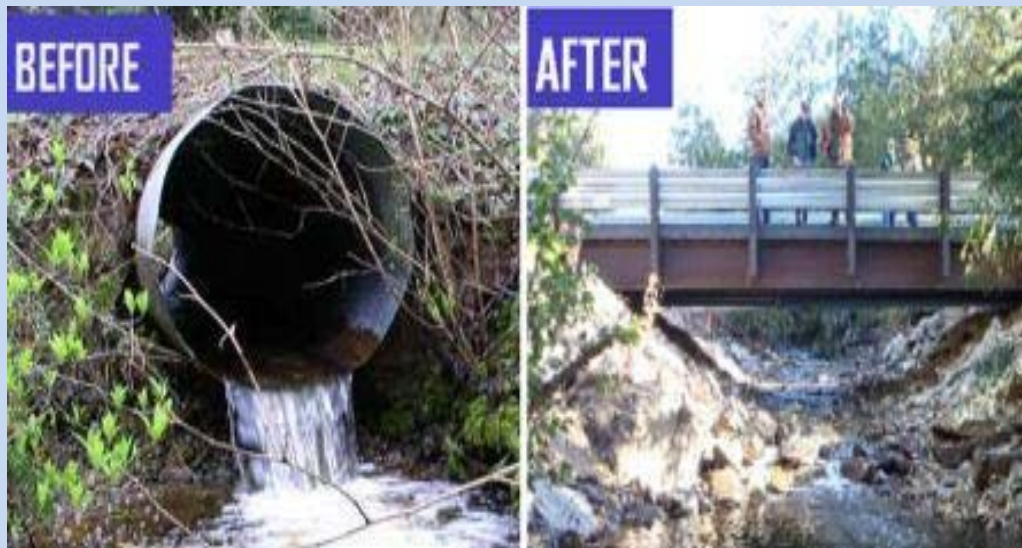
Solution #2

- Taking out the culvert and have the stream naturally flow underneath the bridge
- Similar to the structural plate arch but less of a restriction to width

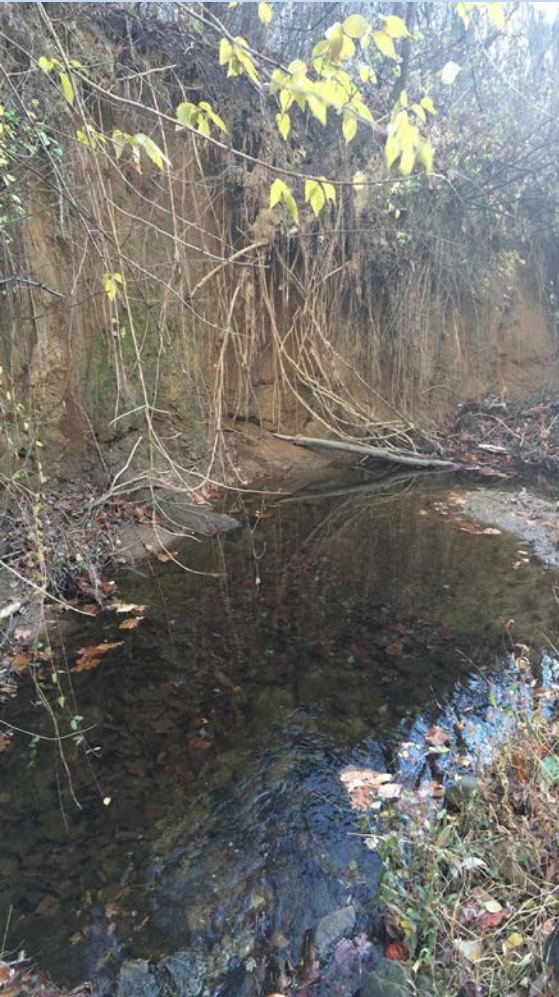
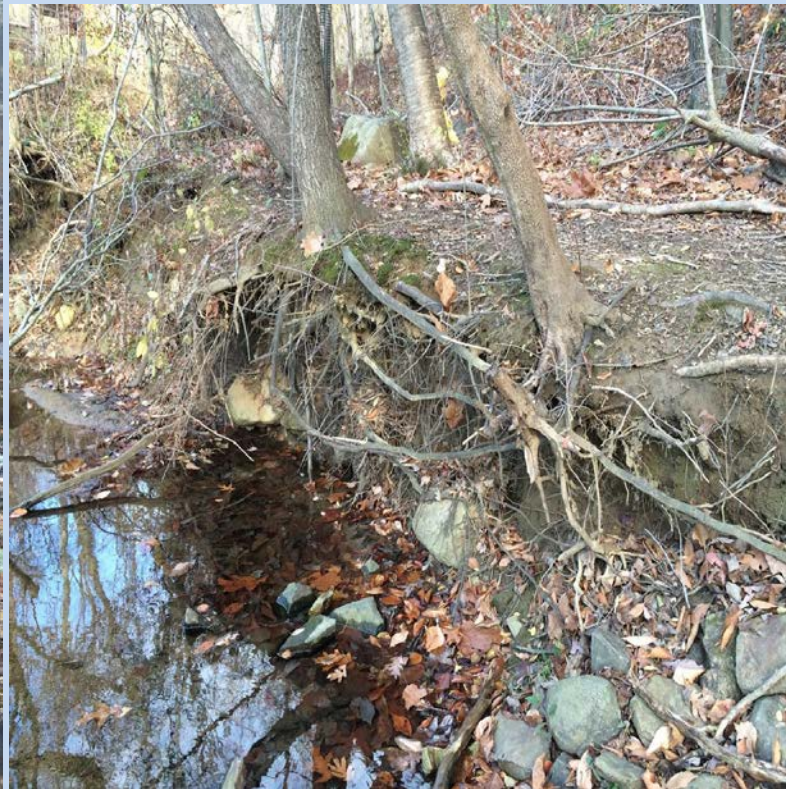
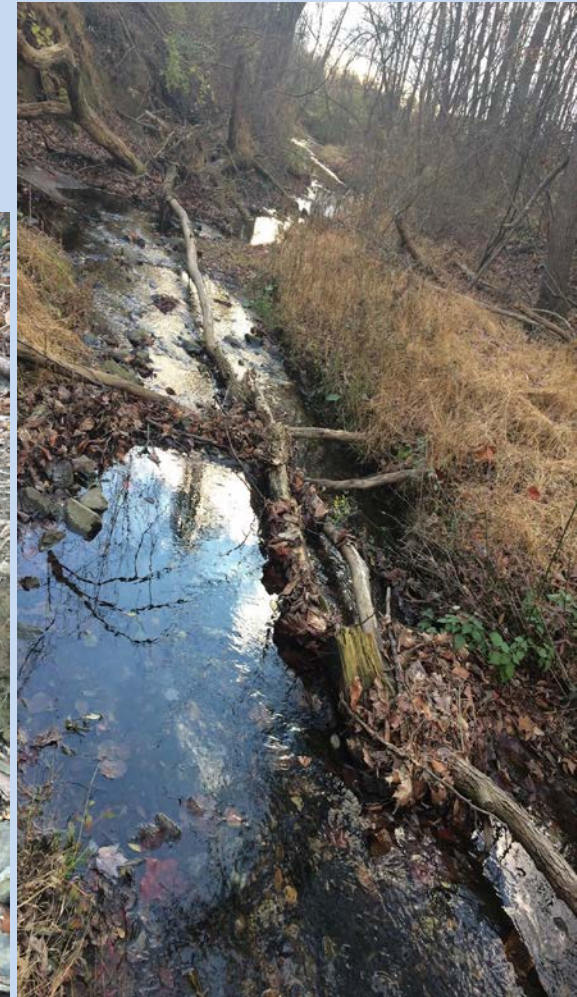
Banks and Sediment Deposition

- Banks are heavily eroded and sediment has been deposited upstream before the culvert
 - Because the culvert is slowing down the flow, sediment has settled out of the water and has been deposited onto the bottom creating a very shallow habitat
 - Erosion of the banks has contributed excess sediment input

- Low flow, very shallow
- Dredge some areas to restore flow rates and reduce sediment build up
- By adding bends it will reduce heavy flow during storms that create erosion downstream
- Reinforcing with stakes

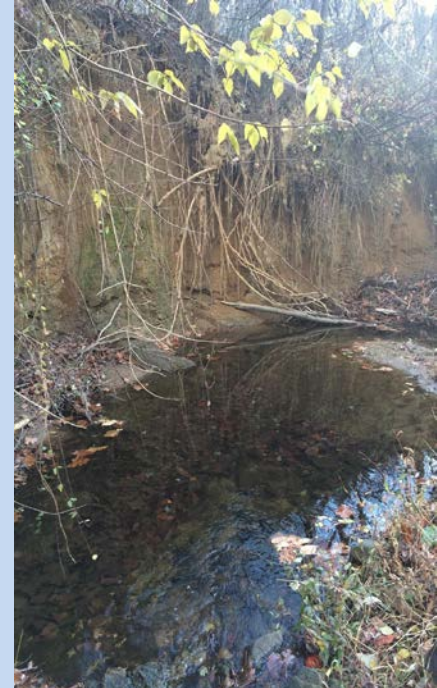
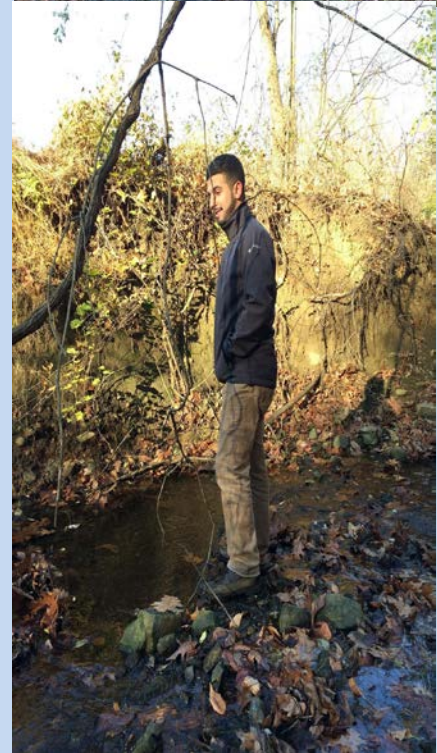
Banks

- Create gradual banks (pull back if possible)
- Erosion blankets
- Plant native vegetation, remove invasives
- Not much room to work with due to road and forest

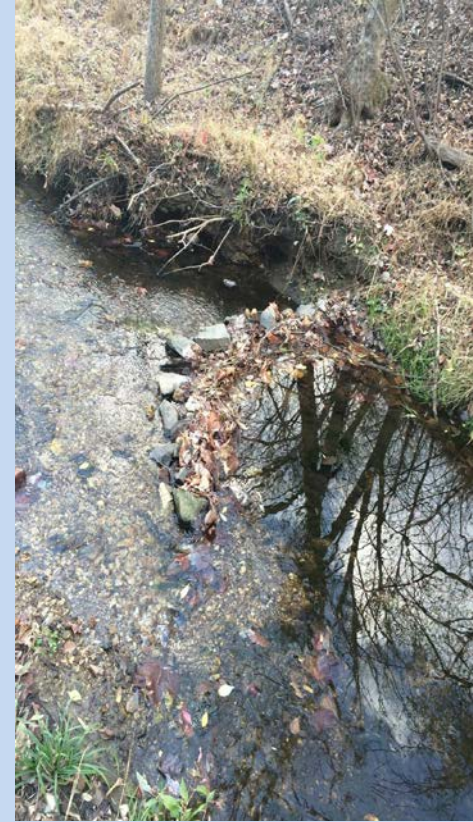
- J hooks and rock dams
- Increased fish habitats

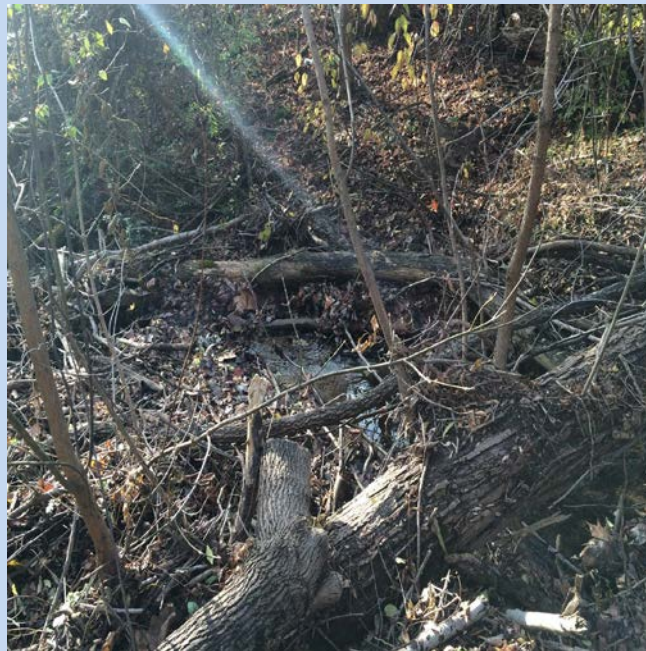
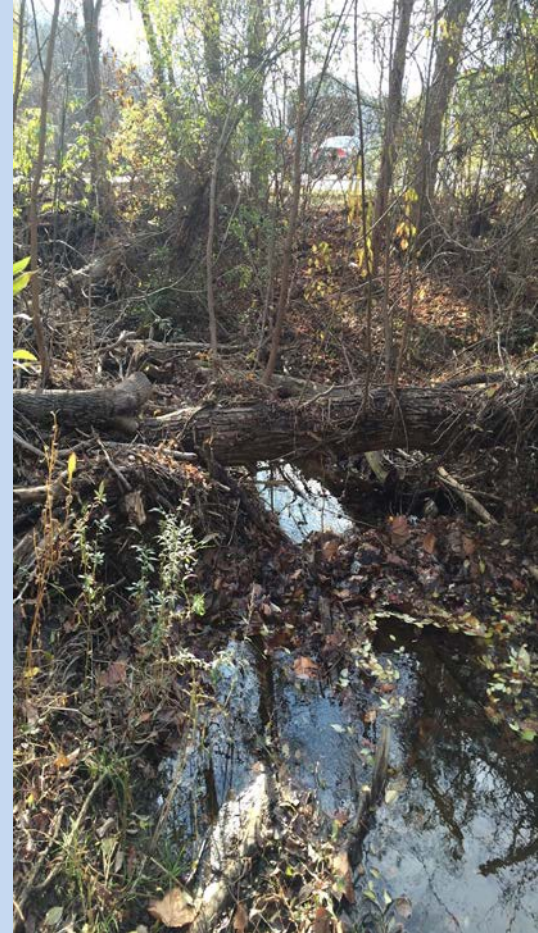
- Cleaning up fallen trees
- Leave some branches and leaf patches

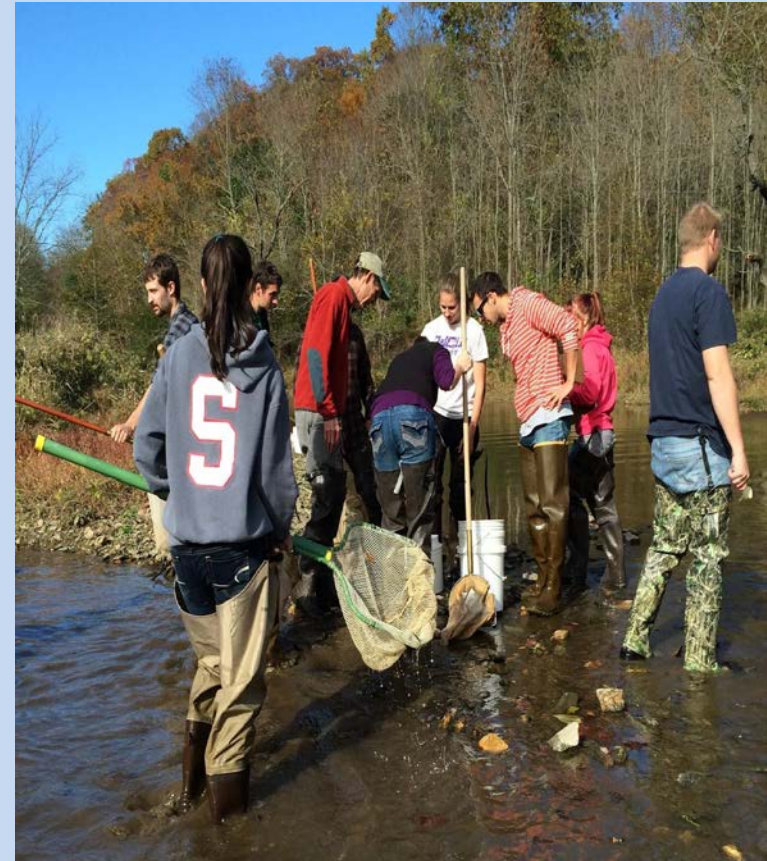
- Work with WCU professors to incorporate monitoring into labs performed at least 1 or 2 times each semester.
- 4 sites for fixed sampling
 - better for trends over time
